NASA APOLLO PROGRAM WORKING PAPER NO. 1333

AN INVESTIGATION OF APOLLO TITANIUM PRESSURE VESSEL
WELDS MADE WITH COMMERCIAL PURE FILLER WIRE

MANNED SPACECRAFT CENTER
HOUSTON, TEXAS
January 1968

Glenn M. Ecord
AST, Materials Technology Branch

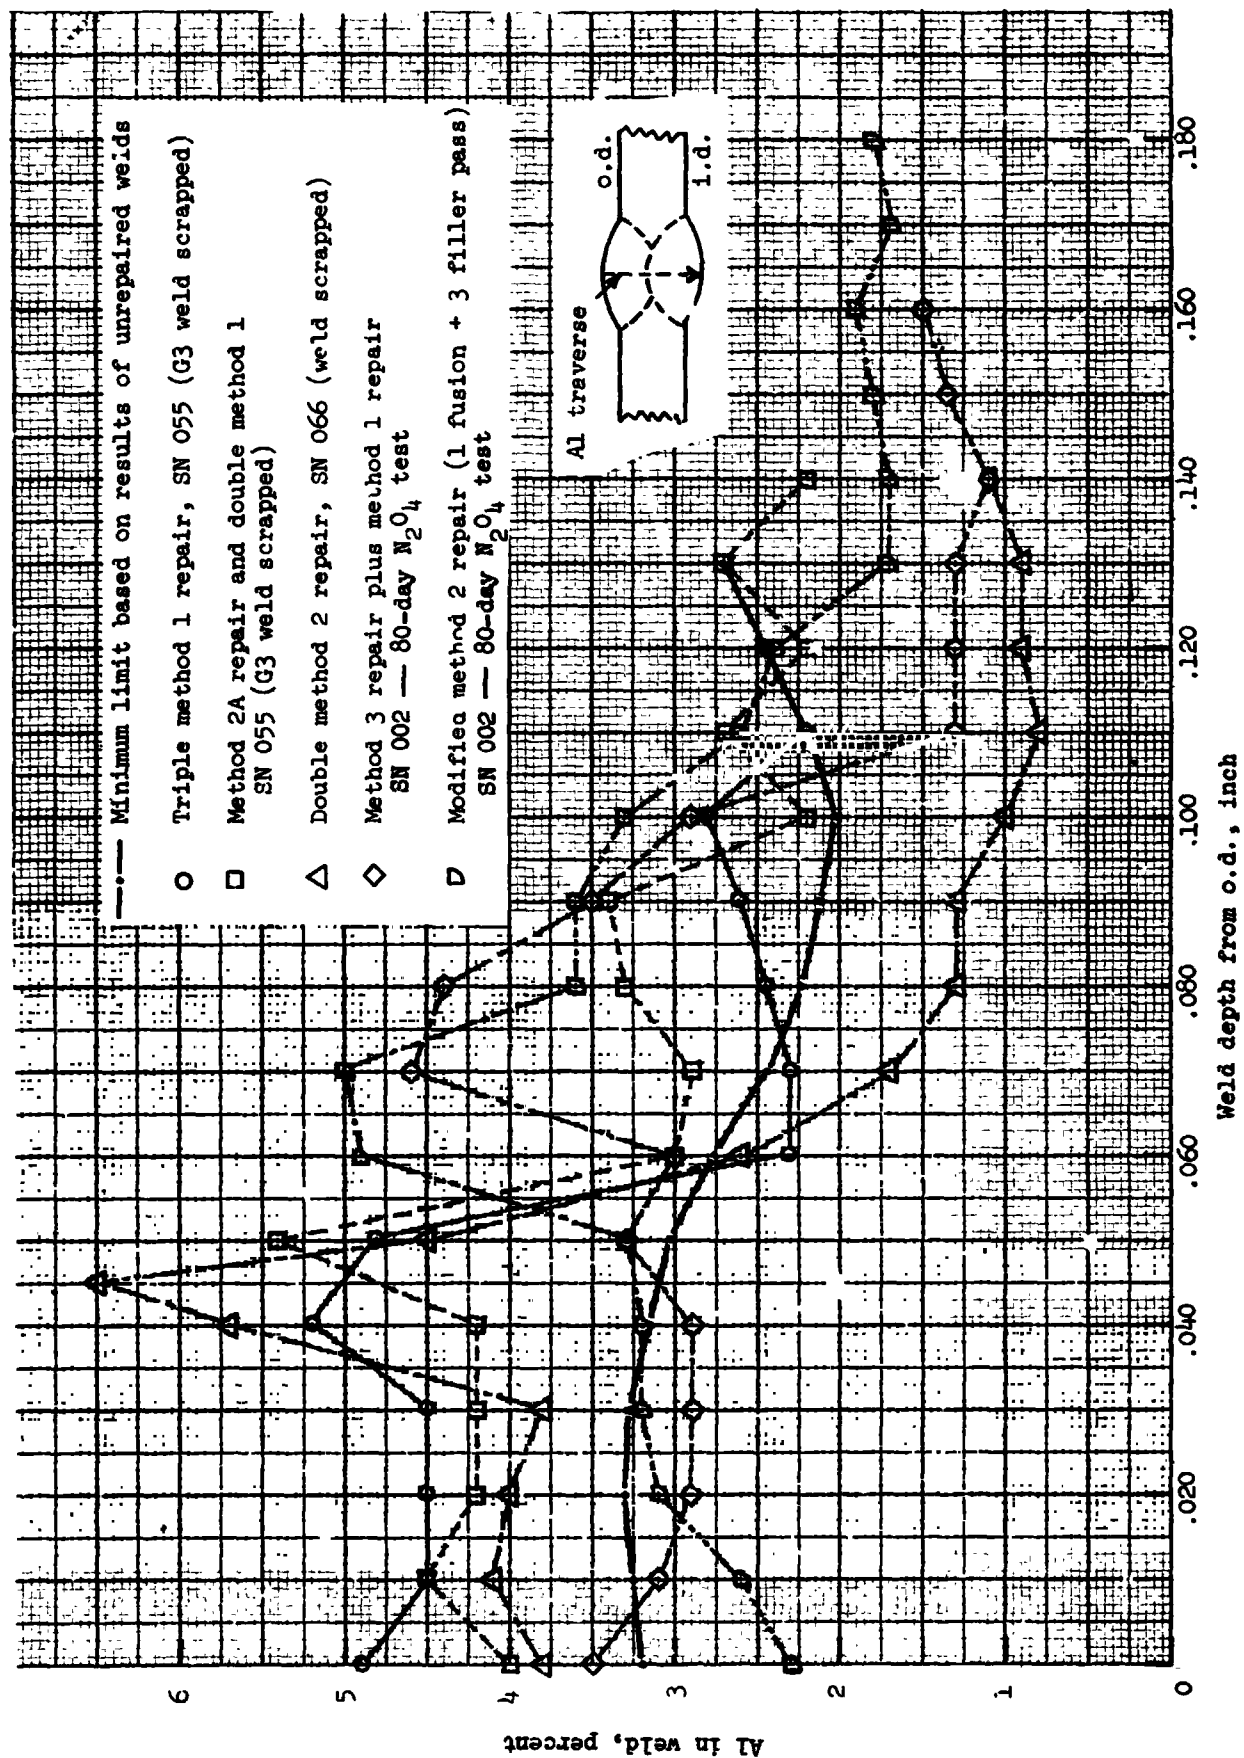
Figure 7.- Comparison of aluminum analysis in unrepaired and worst case repaired welds of SM/SPS propellant vessels.

Figures 6, 7, and 8 show the average and minimum compositions of the Apollo welds and weld repairs as determined by electron probe traverses. Hydrogen analyses of Apollo welds show the content to be less than 70 ppm in all cases examined.
